***Final Consolidated Reconnaissance
Report for Sharps Island, Maryland
For Potential Beneficial Use and
Habitat Restoration***

**Prepared by:
Andrews, Miller and Associates, Inc.
Cambridge, Md.**

December 2002

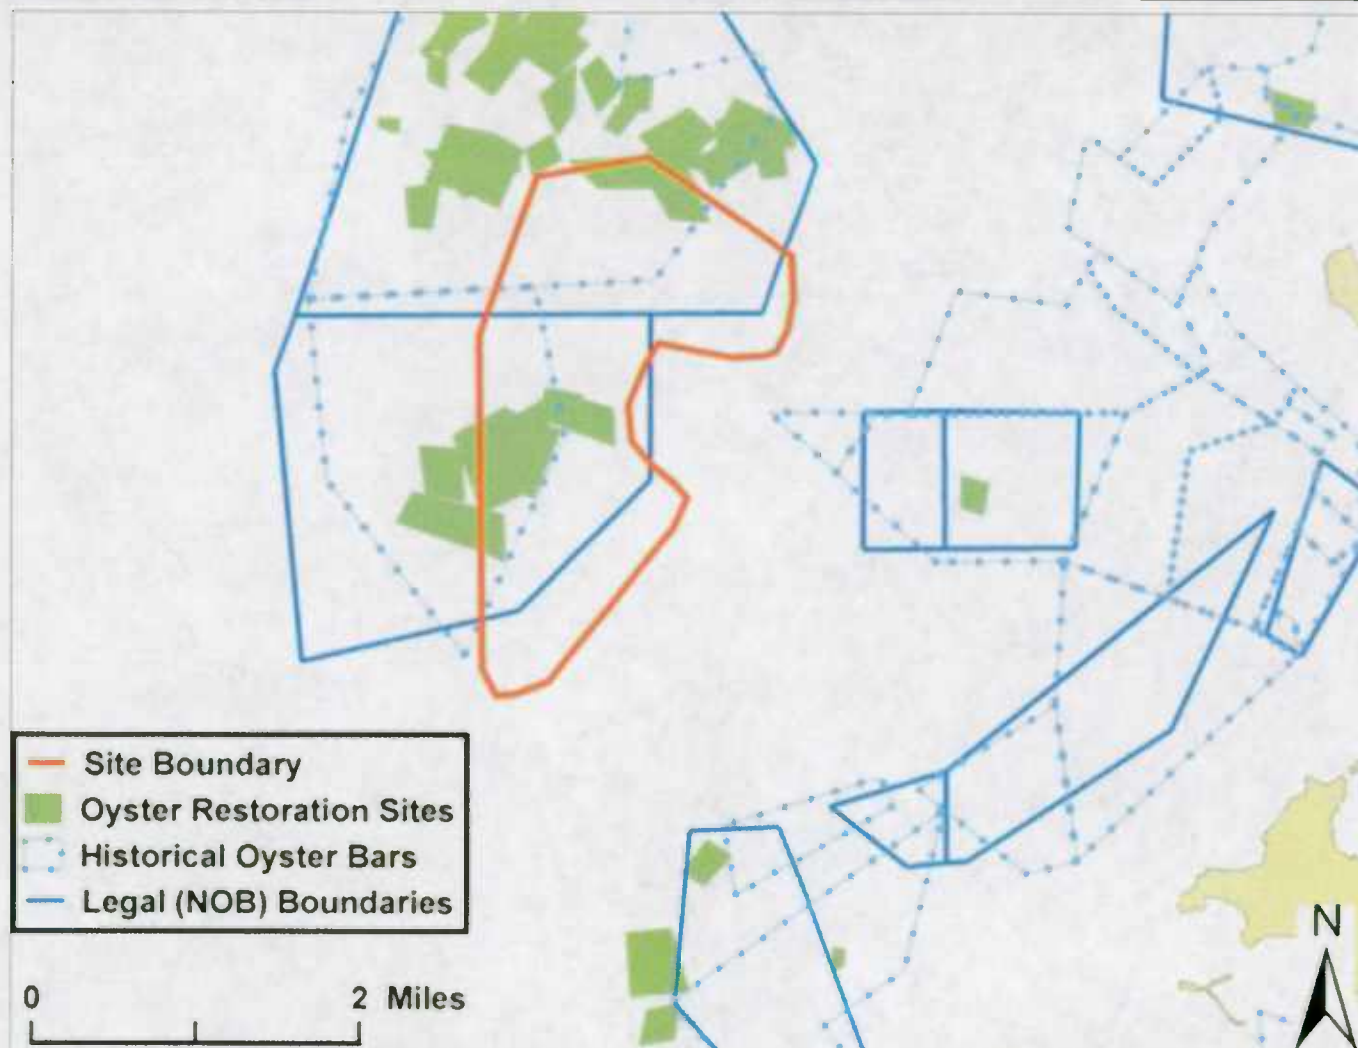
FIGURE
4-2

- Figure 4-2. Commercial and Recreational Fishing in the Vicinity of Sharps Island.
- Figure 4-3. Historic and Present Oyster Bar Boundaries, Including Oyster Restoration Sites.

Correspondence with the Natural Resources Police indicated that the Sharps Island area provides a valuable resource for commercial fisheries. It was noted that pound net fishermen catch a broad variety of fish in the area (ECR Figure 4-2). It was also noted that Sharps Island and the immediate vicinity contain productive oyster bars (ECR Figure 4-3). Drift gill net fishing occurs in the area during the striped bass gill net season. Blue crab harvesting in the area primarily consists of crab pots. Clam fisheries are not prevalent at Sharps Island with the closest being approximately 1.5 miles from the area of interest (ECR p.5-2).

Recreational fishing and oyster resources are found in the Sharps Island vicinity. Figure 4-2 (ECR) indicates the recreational fishing grounds bordering the Proposed Concept Area, and

Commercial and recreational resources in the Chesapeake Bay include many valuable finfish and shellfish species. The mid-section of the Chesapeake Bay supports diverse commercial and recreational resources. Recreational fishing locations in the immediate vicinity of Sharps Island are presented in Figure 4-2. Finfish species that occur or have the potential for existing in the mid Chesapeake Bay mesohaline environment are listed in Table 4-2 (CBP, 1998). Essential Fish Habitat (EFH) includes waters and substrate necessary to fish for spawning, breeding, feeding or growth to maturity (NMFS, 2002). Site-specific EFH include Bluefish, Summer flounder, Spanish Mackerel and Red Drum. These four EFH species are included as species of concern for the Sharps Island vicinity (Table 4-1).

Commercial and recreational resources in the Chesapeake Bay include many valuable finfish and shellfish species. In particular, the mid-section of the Chesapeake Bay supports diverse commercial and recreational resources. Common fishing locations in mid Chesapeake Bay are presented in Figure 4-1. Area-specific recreational fishing locations in the immediate vicinity of Sharps Island are presented in Figure 4-2.

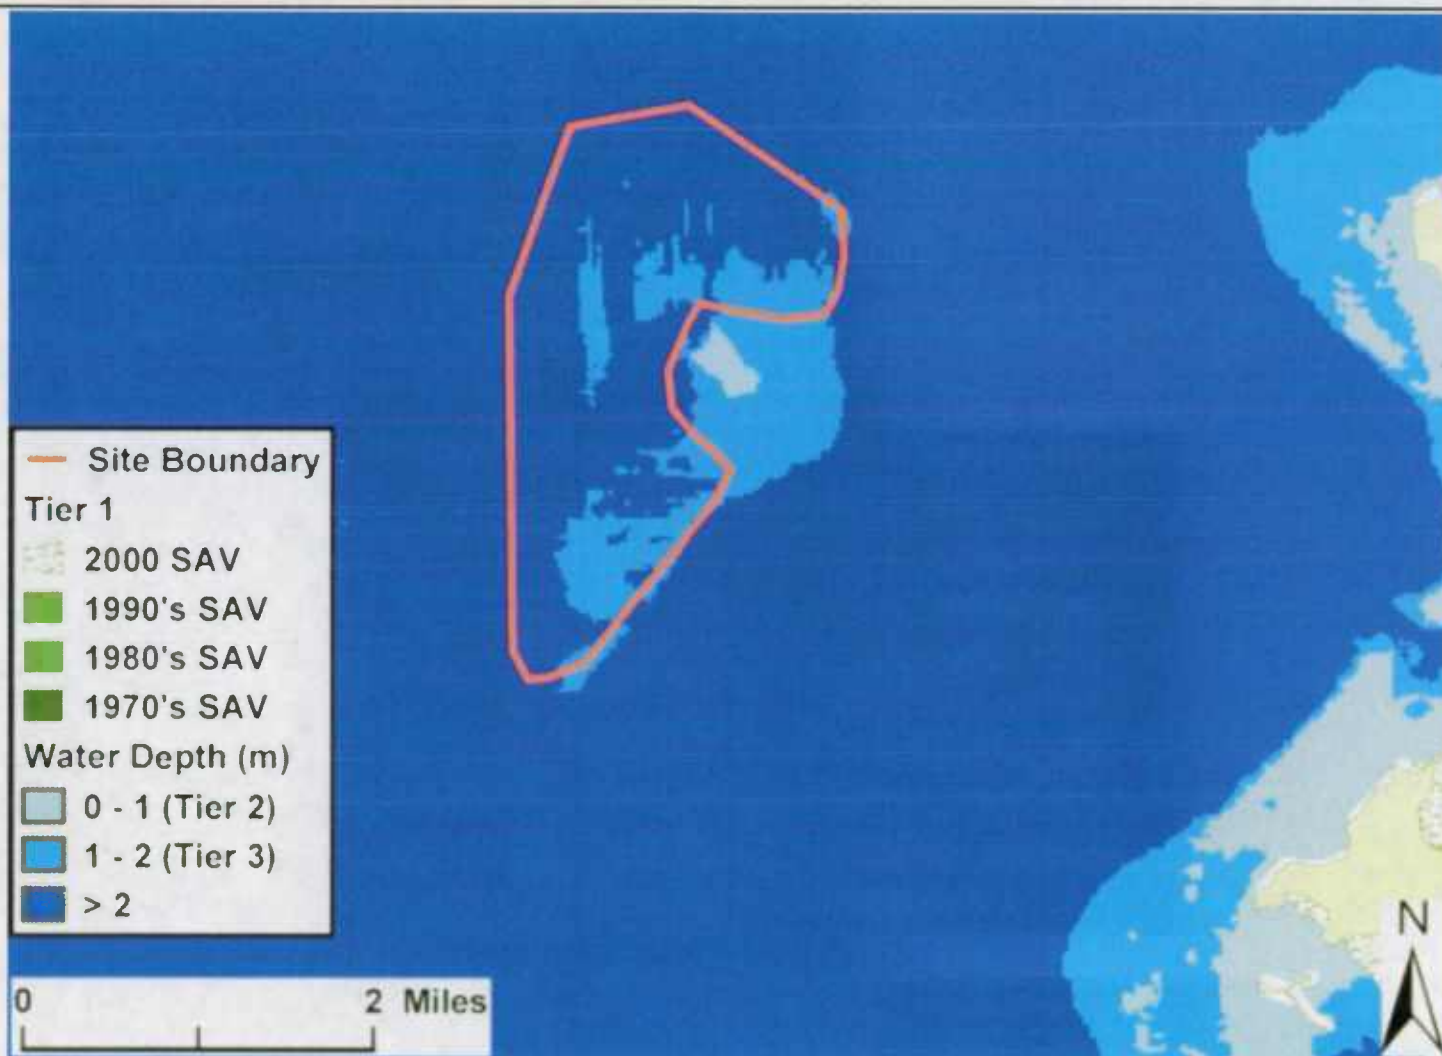
FIGURE
4-4

- Figure 4-4. Submerged SAV Bay Grass Acreage 1984-2000: Total Coverage for Outer Choptank River Area CHOMH1.
- Figure 4-5. Water Depth and Trends in SAV Presence in the Vicinity of Sharps Island.
